平成25年12月に神奈川県三浦市において発生した米海軍第5空母航空団  
所属MH-60ヘリ不時着・横転に係る事故調査報告書（概要）について

## Summary of HSC-12 Mishap Investigation

## 第12海上戦闘ヘリコプター飛行隊事故調査概要

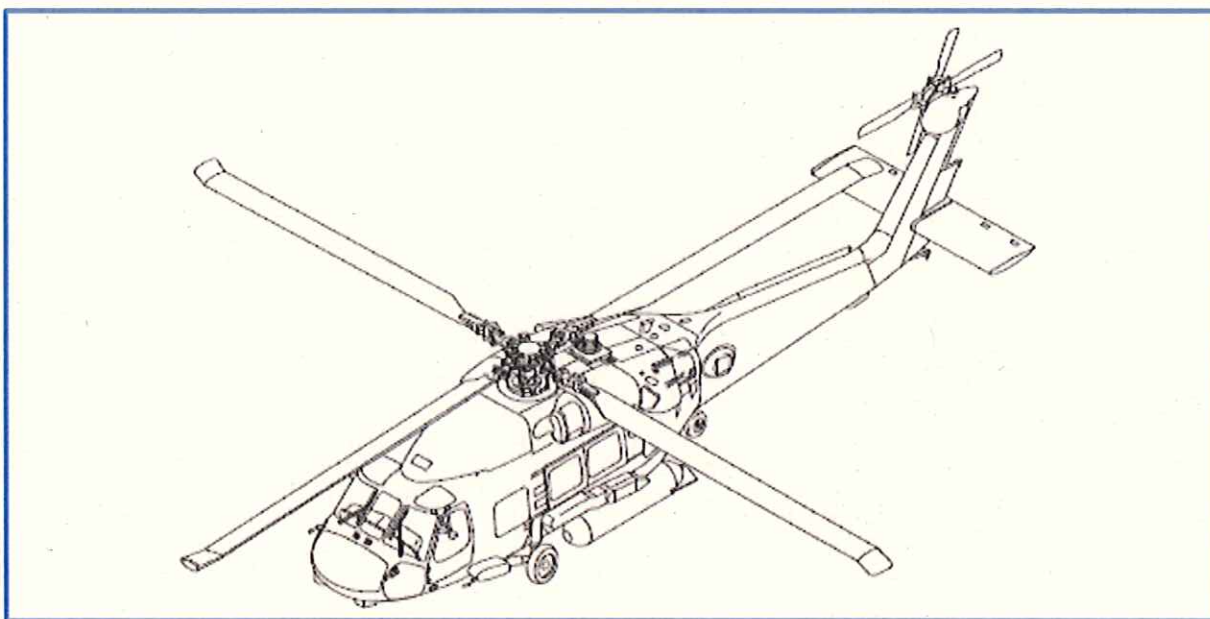
Fig. 1. MH-60S

Helicopter Sea Combat Squadron 12 (HSC-12) aircraft #613, a Sikorsky Multimission Helicopter (MH)-60S (fig. 1) experienced a hard landing on Miura Peninsula while conducting a post maintenance check flight in accordance with proper doctrine/procedures on 16 December 2013 (at 3:31 PM). *A post maintenance check flight is a flight of the aircraft conducted after various maintenance actions have been done on the aircraft to ensure that it is functioning properly.*

Aircrew flew for approximately 1.0 flight hour before losing the tail rotor drive that resulted in the aircraft commander conducting a hard landing.

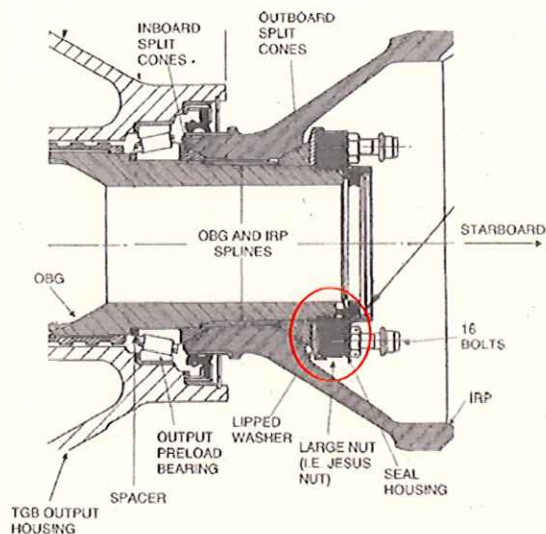
Fig. 2. Large Nut

Post mishap assessment concluded that loss of tail rotor drive was due to improper installation of the inboard retention plate via large washer and nut assembly (fig. 2). The Large Nut attaches the inboard retention plate and tail rotor head to the output bevel gear (fig. 3).

During the V<sub>H</sub> run, the Large Nut began to loosen from its position on the output bevel gear. The inboard retention plate slid off and the tail rotor head moved outboard and contacted the pitch beam.

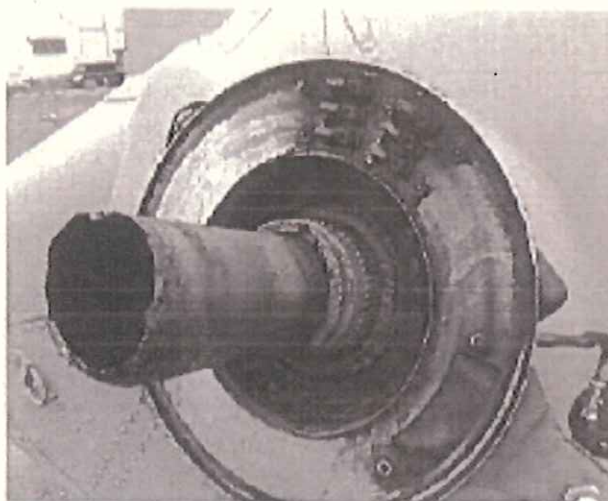
Fig. 4. Pitch control shaft

This caused the pitch control shaft to fail (fig. 4).

The inboard retention plate and tail rotor head departed the pitch control shaft, leading to loss of the tail rotor drive, which caused the mishap.

When the tail rotor head and inboard retention plate were removed and reinstalled in February 2013 following damage to tail rotor de-icing wiring harness and tail rotor slip ring assembly, the inboard retention plate was not correctly re-installed nor was the maintenance

action properly recorded into the aircraft maintenance database (i.e. this accident was caused by human error).

Since the mishap, HSC-12 has revised and heavily focused on all facets of the squadron from following proper maintenance procedures/Standing Operation Procedures, to "Safe for Flight" (SFF) qualification process, to modifying squadron pilot/aircrew training syllabi placing greater emphasis on proper maintenance actions and SFF policies/procedures. The HSC-12 Safety Department now plays a more integral role in all maintenance on a daily basis.

Since the mishap, the Commanding Officer, the Maintenance Officer, the Maintenance Material Control Officer and the Maintenance Master Chief Petty Officer have all been replaced in HSC-12. Hence it is an entirely new maintenance team and chain of command that is keenly aware of the specifics of this mishap and the need to follow correct maintenance procedures at all times.

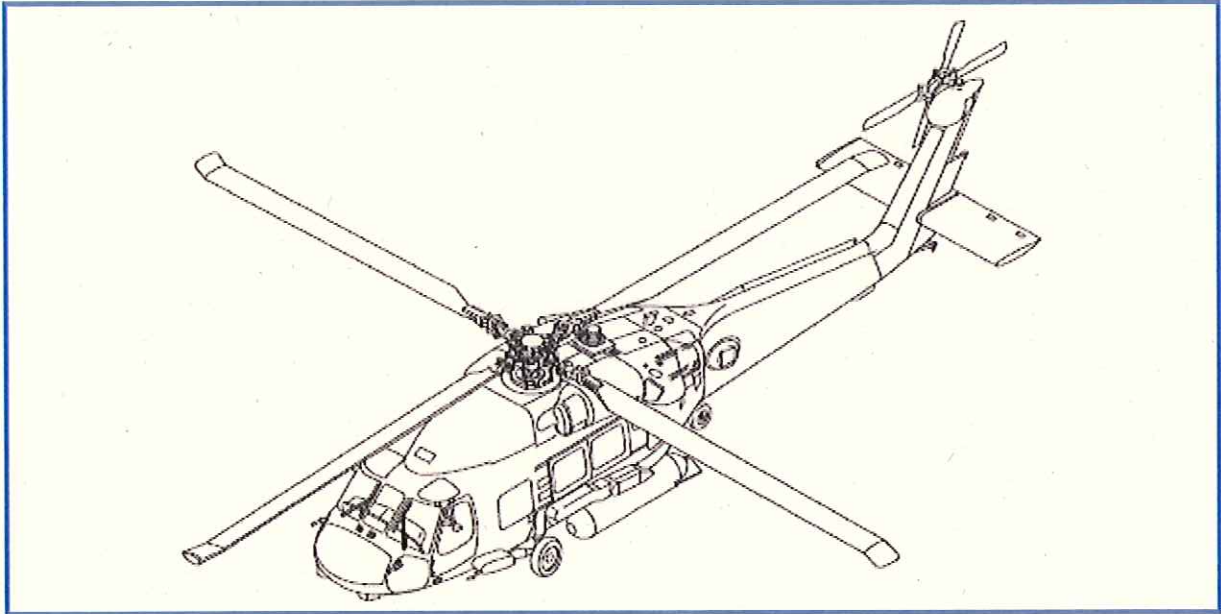
図1. MH-60S

2013年12月16日(午後3時31分)、第12海上戦闘ヘリコプター飛行隊(HSC-12)機体番号613、シコルスキー社製多用途ヘリコプター(MH)-60S(図1)が、適切な原則/手順に従い整備後点検飛行を実施中、三浦半島でハードランディングを行った。整備後点検飛行は、航空機が適切に機能していることを確保するため、様々な整備作業が機体に行われた後に実施される航空機の飛行である。

機長がハードランディングを実施する結果となったテール・ローター動力の損失前に、搭乗員は約1.0時間の飛行を行った。

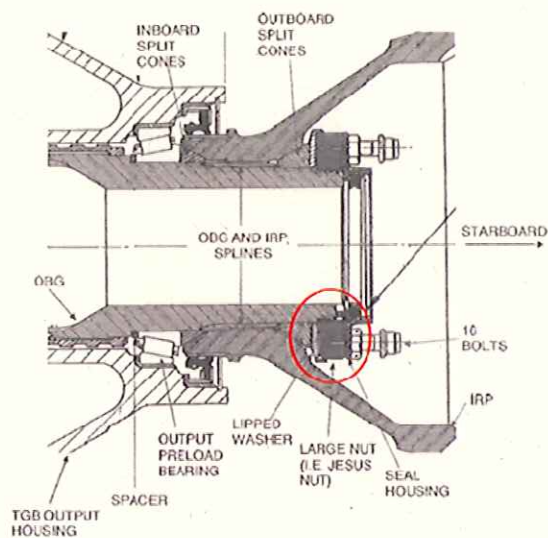
図2. 大ナット

事故後評価は、テール・ローター動力の損失は、大ワッシャー(ボルトの座金)及びナットの組立て部品により、インボード・リテンション・プレート(内側の留め金板)が適切に取り付けられていなかったことによるものと結論付けた(図2)。大ナットは、インボード・リテンション・プレートとテール・ローター・ヘッドをアウトプット・ベベル・ギアに取り付けている(図3)。

最大出力による整備後点検飛行中、大ナットがアウトプット・ベベル・ギア上の定位置から緩み始めた。インボード・リテンション・プレートが滑り、テール・ローター・ヘッドが機体の外側へ動き、ピッチ・ビームに接触した。

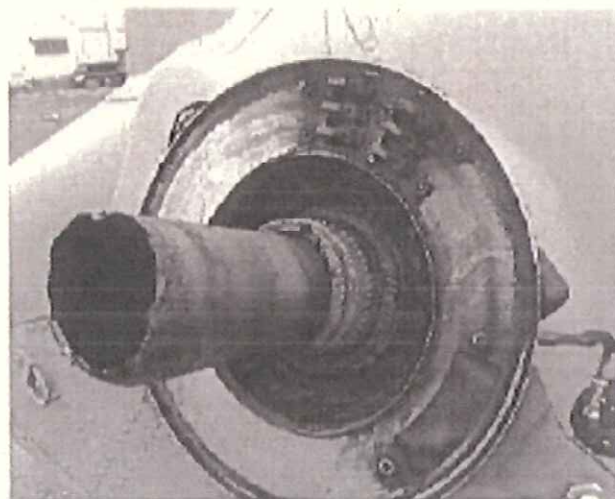
図4. ピッチ・コントロール・シャフト

これにより、ピッチ・コントロール・シャフト（縦揺れ制御シャフト）が機能しなくなった（図4）。

インボード・リテンション・プレート及びテール・ローター・ヘッドがピッチ・コントロール・シャフトから離脱し、テール・ローター動力の喪失につながり、事故を起こした。

テール・ローター着氷防止ワイヤー・ハーネス及びテール・ローター・スリップ・リングの組立て部品への損害を受けて、2013年2月にテール・ローター・ヘッド及びインボード・リテンション・プレートを取り外し、再度取り付けた際、インボード・リテンション・プレートが正確に再取り付けされておらず、また、整備状況が航空機整備データベースに適切に記録されていなかった（つまり、本事故は人為的ミスによるものであった）。

事故以降、HSC-12は、適切な整備作業及びSFF（飛行安全）ポリシー／手続により一層重点を置きつつ、適切な整備手続／標準実施要領から、「飛行安全」（SFF）資格取得プロセス、飛行隊のパイロット／搭乗員の訓練シラバスの修正に至るまで、飛行隊のあらゆる面を修正し、重点的に焦点を当てた。現在、HSC-12安全部は、常日頃から全ての整備においてより必須な役割を果たしている。

事故以降、HSC-12の司令官、整備士官、整備資材管理士官及びメンテナンス最先任上級上等兵曹が総交代となった。したがって、今回の事故の詳細及び常に正確な整備手続に従う必要性についてしっかり認識している整備班及び指揮系統に刷新された。
